# **Development of a New Potato Seepage Irrigation and Drainage Area in Hastings**

## **Report – Deliverable 9b (FDACS – Contract # 017259) (UF – Contract # 0083268)**

June, 2012

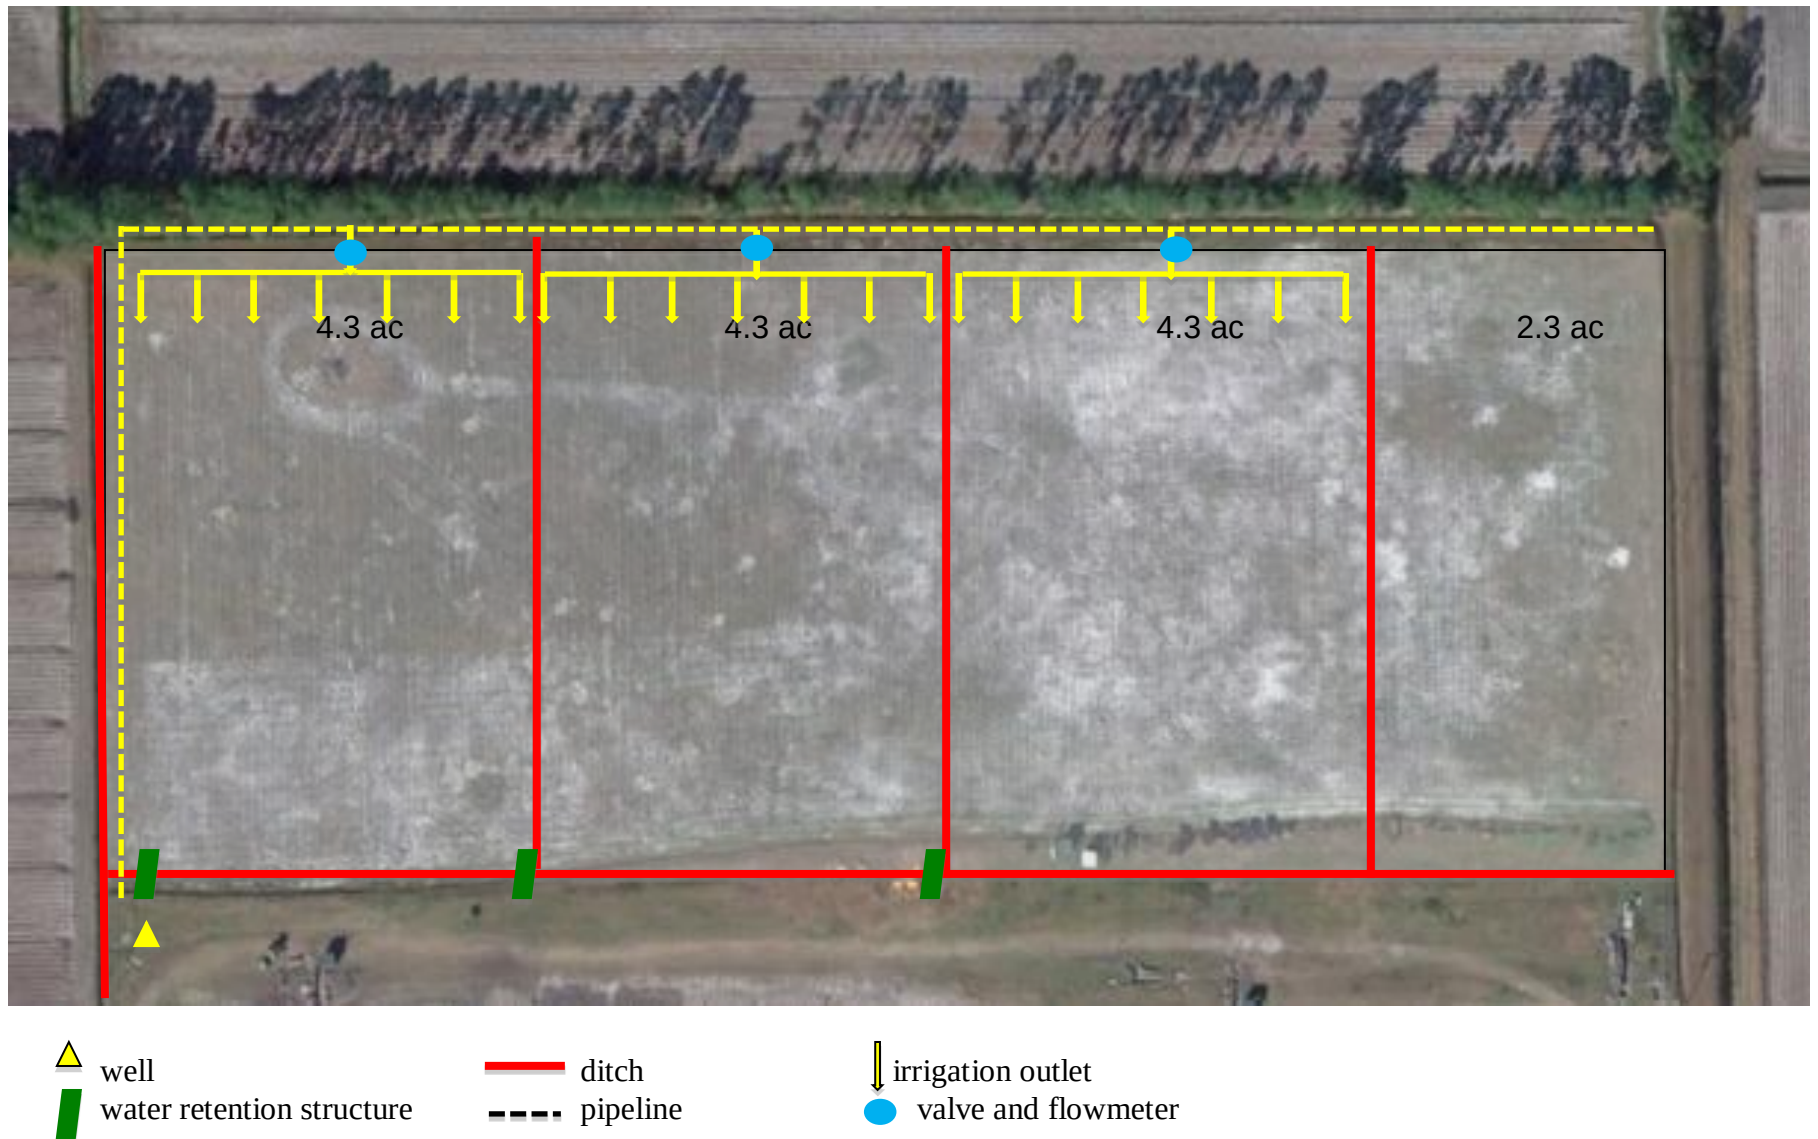
Figure 1. Layout of irrigation and drainage structures on an aerial photograph of the 15.2 acre area at the Experimental Station of Florida Partnership for Water, Agriculture & Community Sustainability at Hastings. (obs. figure not in scale).

Figure 1 shows the layout of the potato production areas after the development of the area as well as the location of the well, irrigation and drainage system components. The area has been subdivided into 4 production sections (or cells); three production cells of 4.3 acres and a fourth

cell of 2.3 acres. Each 4.3 acre cell will be controlled by a single valve (with solenoid) connected to the 6" main.

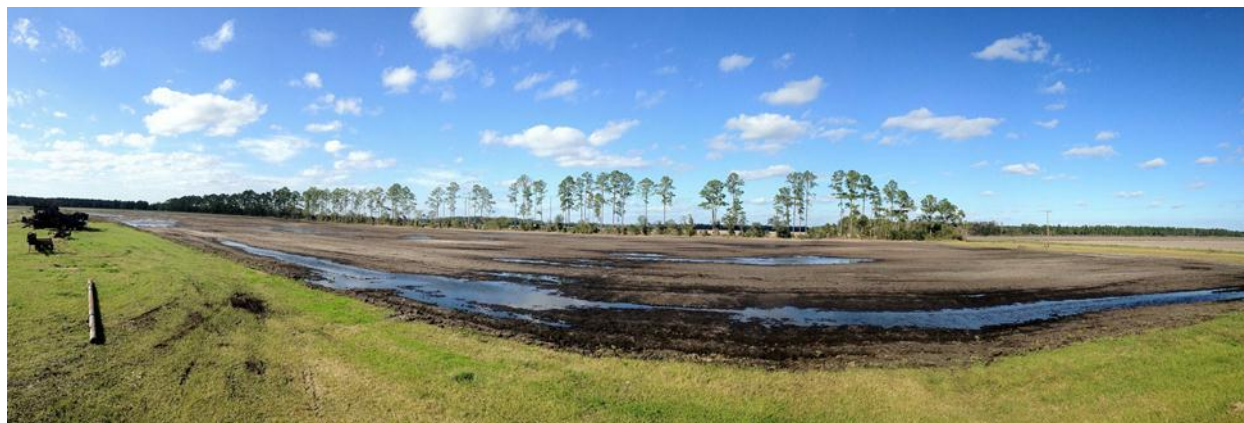
Figure 3. Overview of the 15.2 acre field at the Hastings Agricultural Experimental Station on Dec. 19, 2011. Detail water ponding on the soil surface 5 days after a rainfall event, occurred between Dec. 11 and 13, 2011 (total of 2.93”).

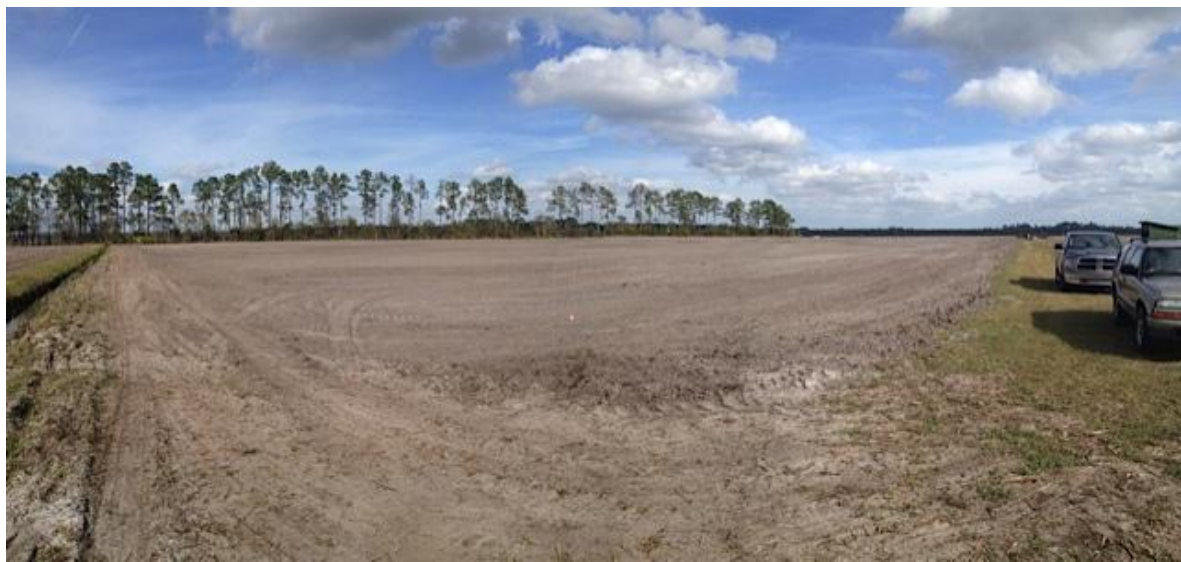
Figure 4. Overview of the 15.2 acre field at the Hastings Agricultural Experimental Station on Januare 2012.

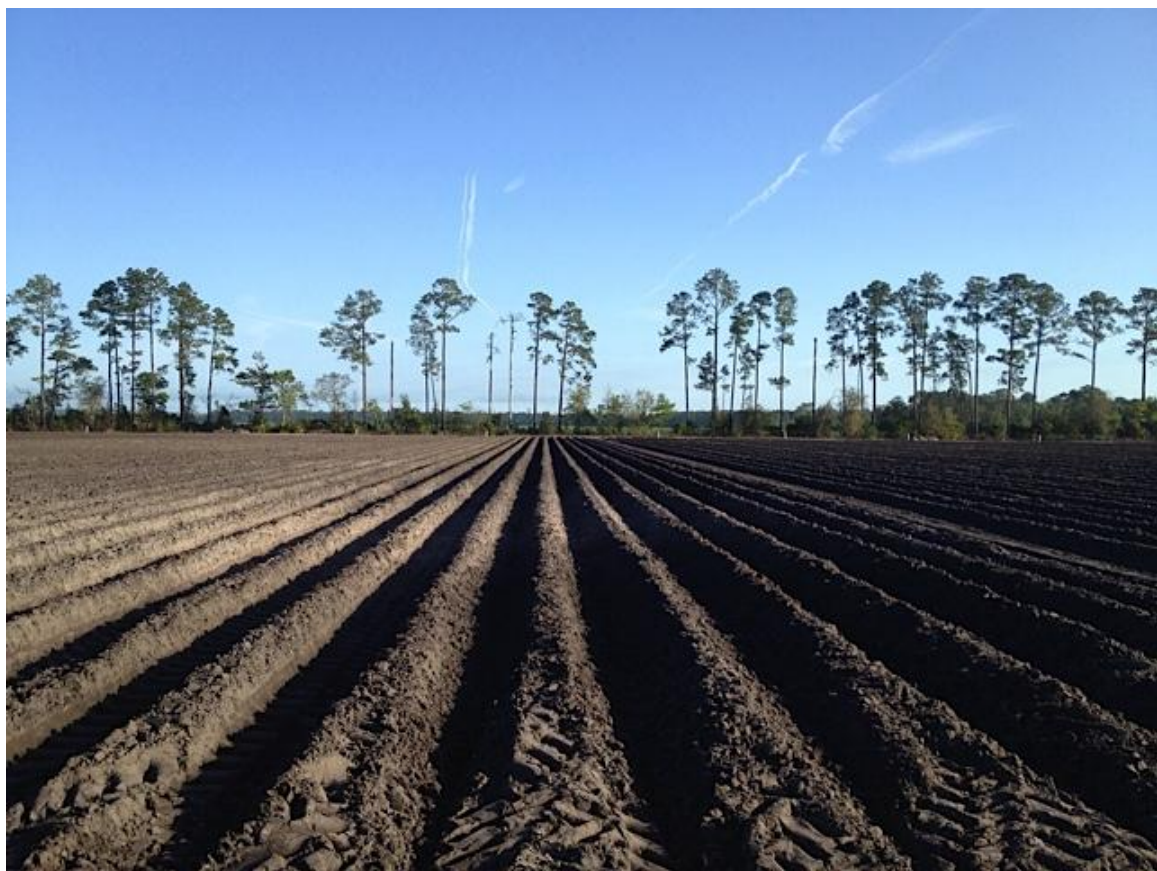
Figure 5. Rows laid down using GPS guided equipment in early April 2012.

January 30, 2012, we initiated the first stages of land leveling. We used a large 12 ft. box blade to rough fill and cut the dips and rises in the field. This was finished by the end of the first week of February 2012. After that we rayne planed the field, which took three days and prepped the land for the laser leveling the week of February 6<sup>th</sup>. Laser leveling took approximately five days. Parallel to the laser leveling process, the tail water ditches were dug. Grades were shot to determine the final layout of the drainage ditches. The final stage of laying down the rows using GPS guided equipment was accomplished March 23, 2012 (Fig. 5).

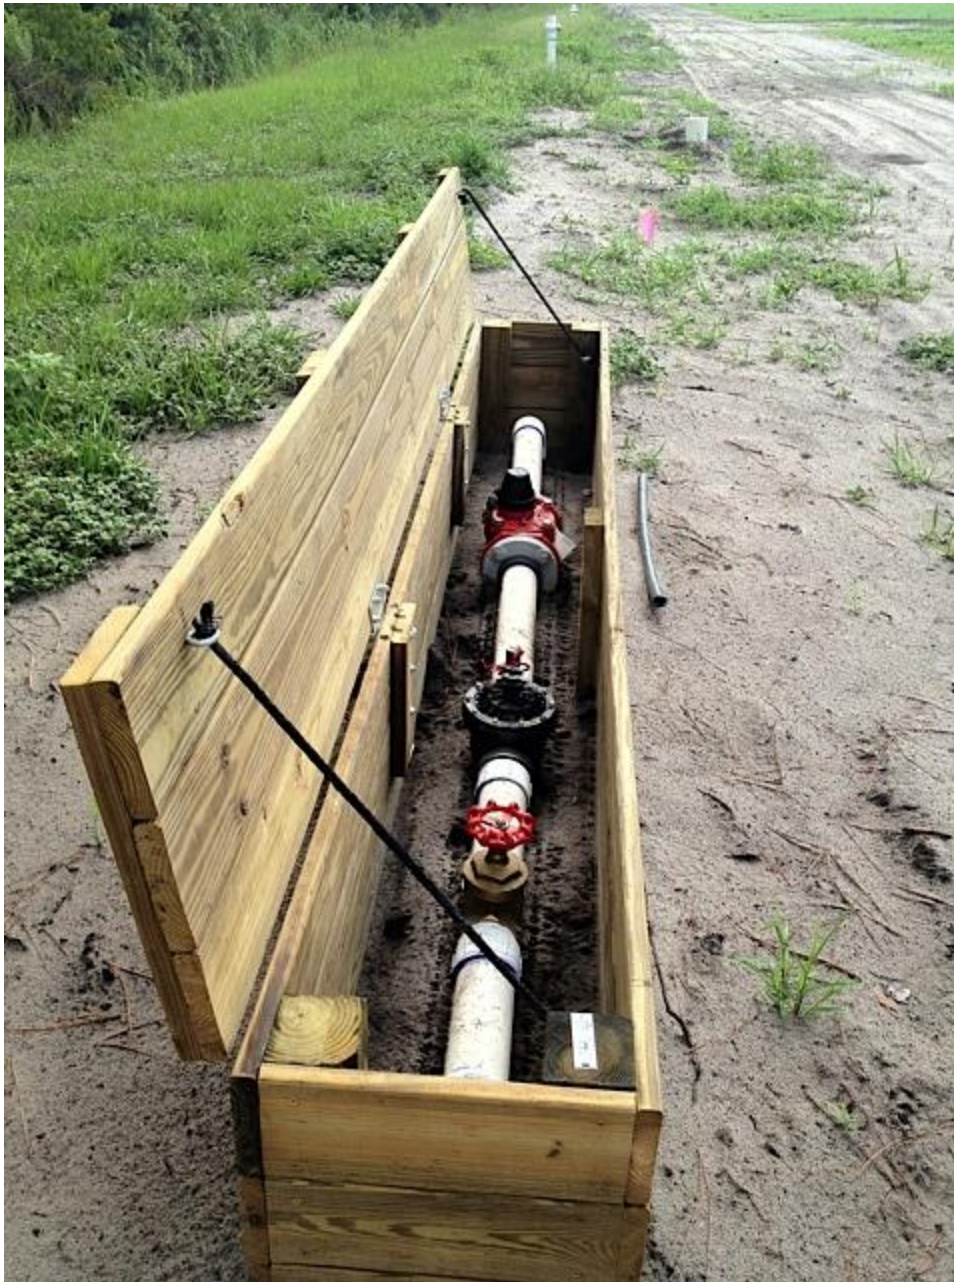
Figure 6. Sample of an irrigation system lateral for each irrigation system block/cell, complete with flow meter and solenoid valve.

The pipeline materials were delivered on third week of January and work began on the irrigation system pipeline the week of February 6<sup>th</sup>. A main pipe (6" diameter) of the irrigation system was installed on the west and north side of the field. Irrigation outlets (spigots) were installed on the north side of the field, according to the traditional furrow distribution of the potato production in the area (60 ft spacing between furrows). The outlets have been fitted with solenoid valves for future automation (Fig. 6).

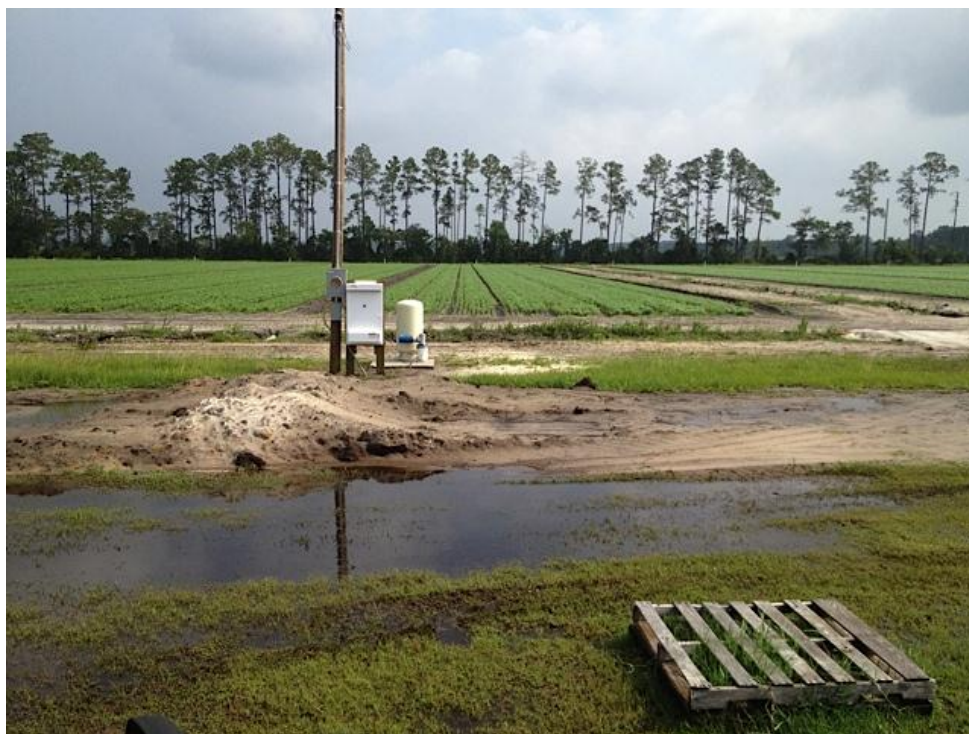
Figure 7. Well and pump station on south west corner of field.

A well drilling permit was obtained at St. Johns River Water Management District (SJRWMD) on September 2011. The District authorized a maximum of 32.80 million gallons a year (mgy) of groundwater from Floridian aquifer for irrigation of 36 acres of potatoes and additional 15.93 mgy for irrigation of 36 acres of sorghum or other miscellaneous crops. The bidding process for well drilling ended in December 2011. An eight-inch well was drilled at the southwestern corner of the field (Fig. 7). The well drilling and pump station installation began May 4<sup>th</sup> and was completed on May 9<sup>th</sup>. The completed pump station was then tied into the recently finished irrigation system pipeline.

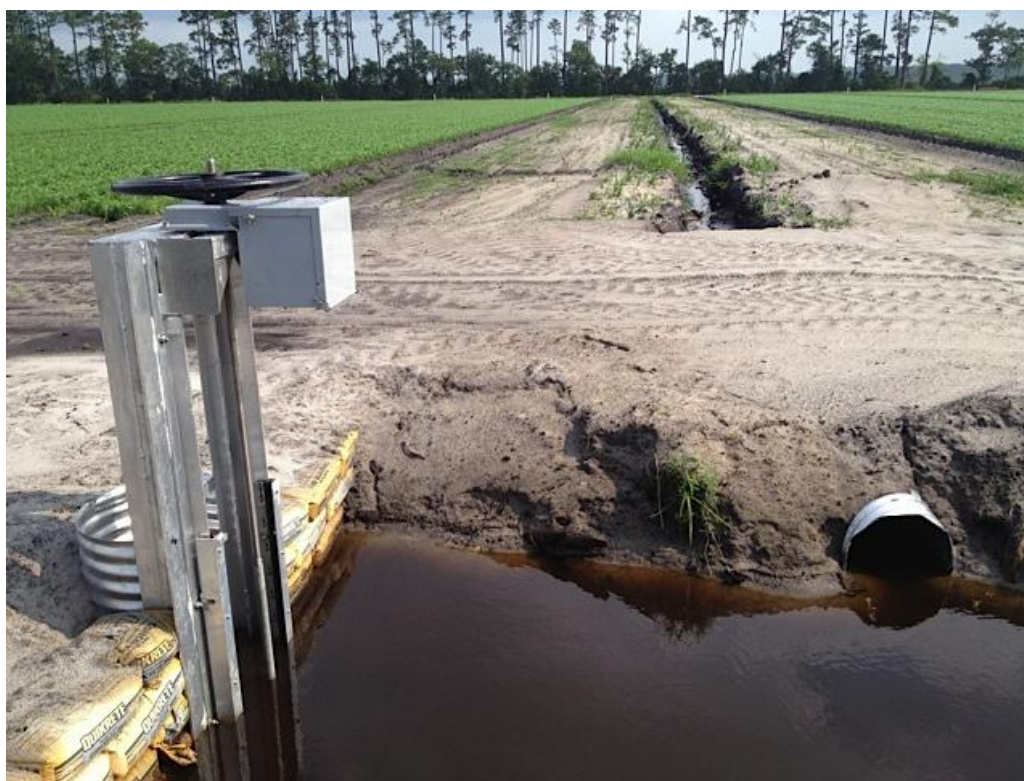
Figure 8. Water retention structure installed in tail water ditch and drainage ditch feeding into tail water ditch. Summer cover crop planted in the new research area.

The water retention structures were installed in the tail water ditches the week of May 21<sup>st</sup> (Fig. 8).
