## **Task 11**

**Project Title:** Watering Station Best Management Practices (BMP) – Effectiveness, Demonstration, and Education

**Project No.** 117714

**Investigating Agency:** University of Florida (UF), Institute of Food and Agricultural Sciences (IFAS)

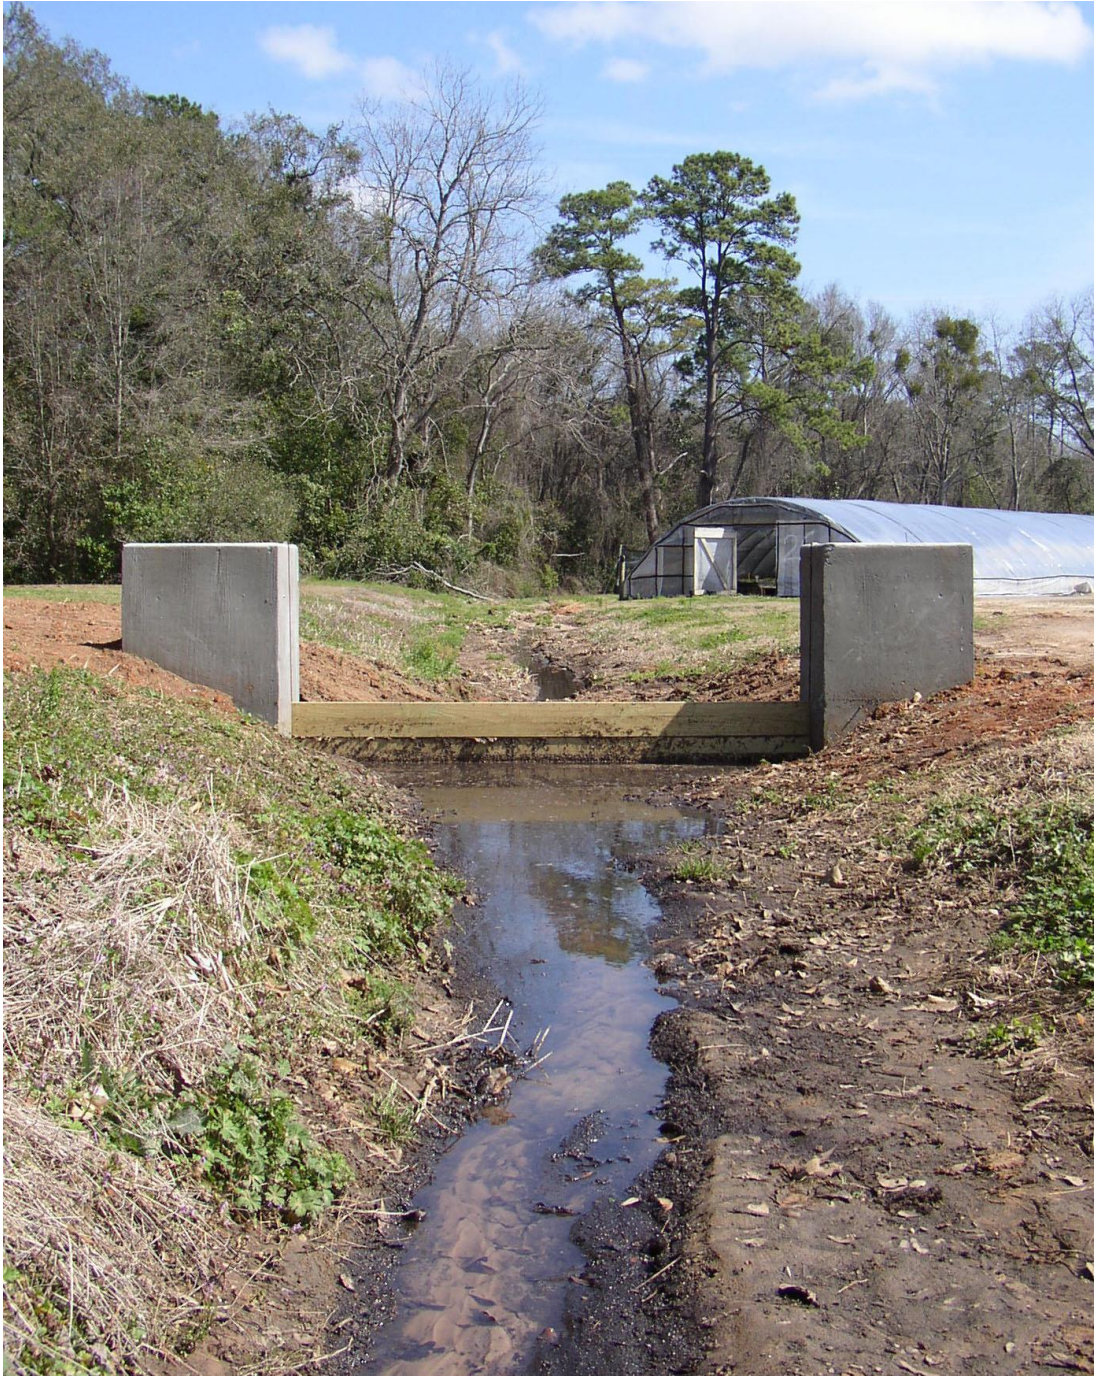
**Figure 2. Photo of wall installed for runoff management.**

A mitigation feature installed in Gadsden County (Site 1) involved the addition of a wall of boards in a ditch (Figs. 1 and 2). The wall created a detention basin that slowed runoff water flow and reduced downstream sediment. For the second feature that was installed in Sumter County (Site 2), a concrete pad was installed and runoff was collected in a channel on one side of the concrete pad (Figs. 3 and 4). The runoff was conveyed down the slope of the channel and traveled by pipe to a grass area.

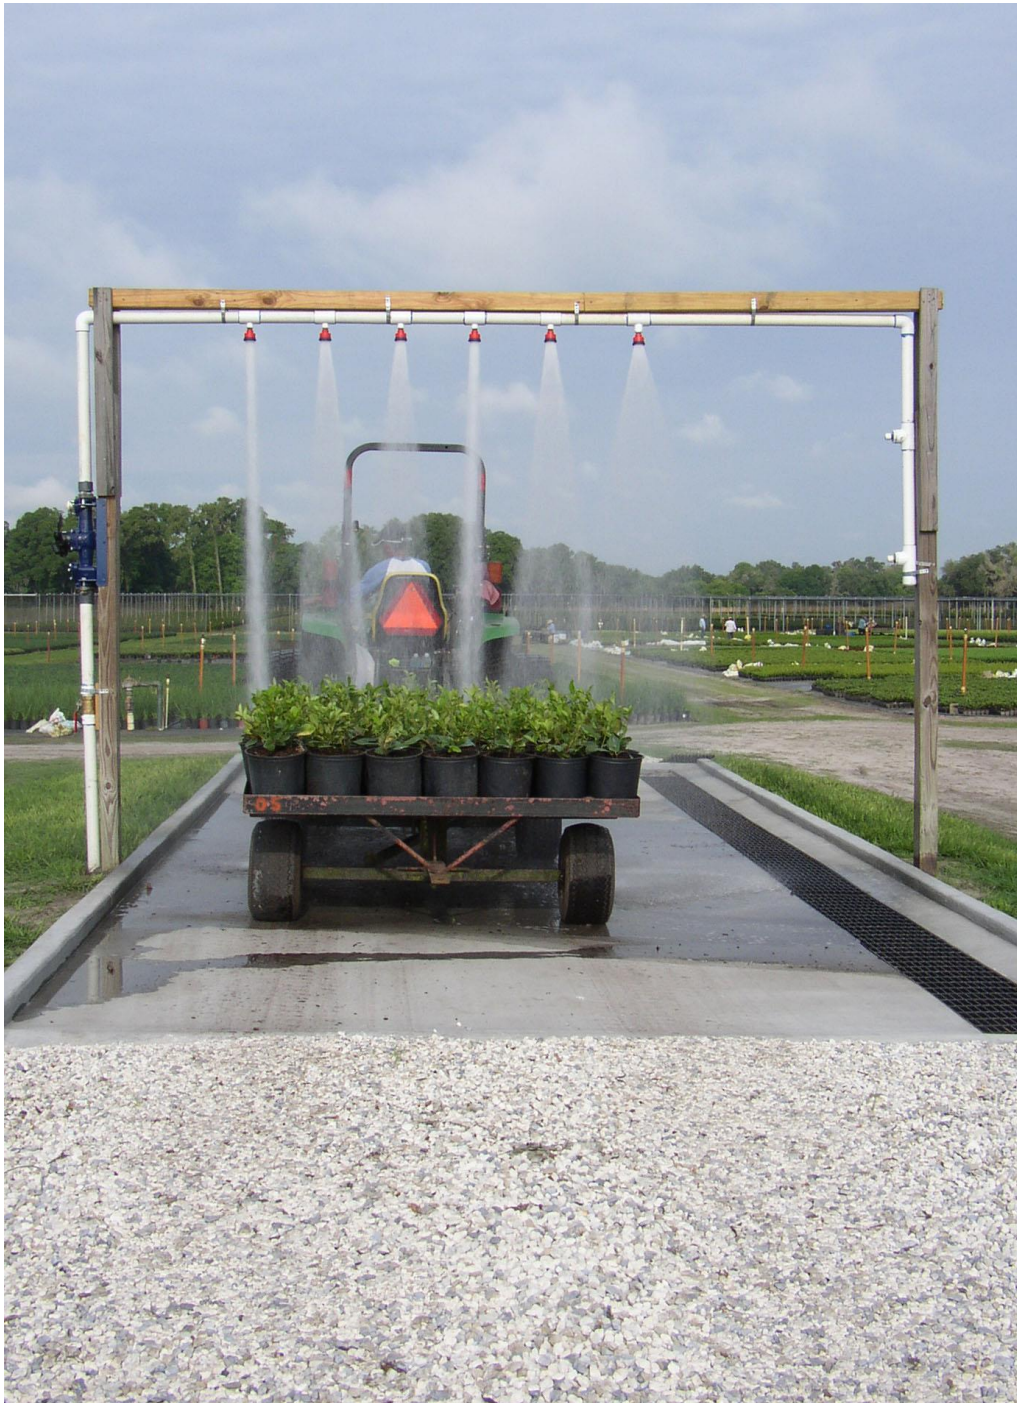
**Figure 4. Photo of concrete pad installed for runoff management.**

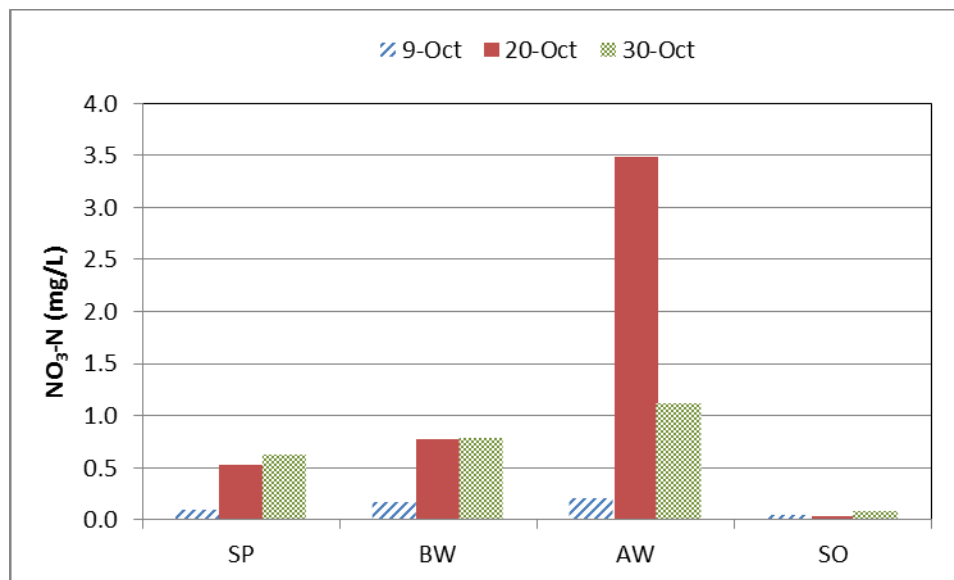
**Figure 5. Mean nitrate nitrogen ( $\text{NO}_3\text{-N}$ ) concentrations (mg/L) for three samples collected Oct. 9, 20, and 30, 2014 from spillway runoff (SP), before proposed wall location (BW), after proposed wall location (AW), and shower water (SO). Samples were collected after a wagon of containers passed under the shower at watering station.**

Shower runoff water and runoff water in conveyance ditch above and below proposed wall location were sampled on Oct. 9, 20, and 30. Three samples were collected at each of the three times from each of three locations (runoff from shower, runoff in ditch before proposed wall location, and runoff in ditch after proposed wall location). Mean concentrations for each sampling time and location are given in Figs. 5, 6, and 7.

Nitrate nitrogen and TKN exhibited an elevation in concentration as samples were collected at locations further away from shower runoff spillway (SP) on Oct. 20 and 30. For example, on Oct. 30 TKN concentration was 7 mg/L at SP, 7.5 mg/L before wall (BW) and 10.3 mg/L after

It is interesting to note that  $\text{NO}_3\text{-N}$  concentrations, particularly at the SP were low, compared to what was expected based on previous research. Million et al., (2007) determined that  $\text{NO}_3\text{-N}$  concentrations in runoff from the initial watering of #1 containers with a hose and breaker were 48-81 mg/L when the substrate was amended with Osmocote® 18-6-12. Nutricote® 18-6-8 was used as the amendment in this evaluation and might have influenced the concentration of nutrients in the runoff. However, an important consideration is that a larger volume of water was applied with the shower and possibly more dilution occurred than in the study by Million et al., (2007).

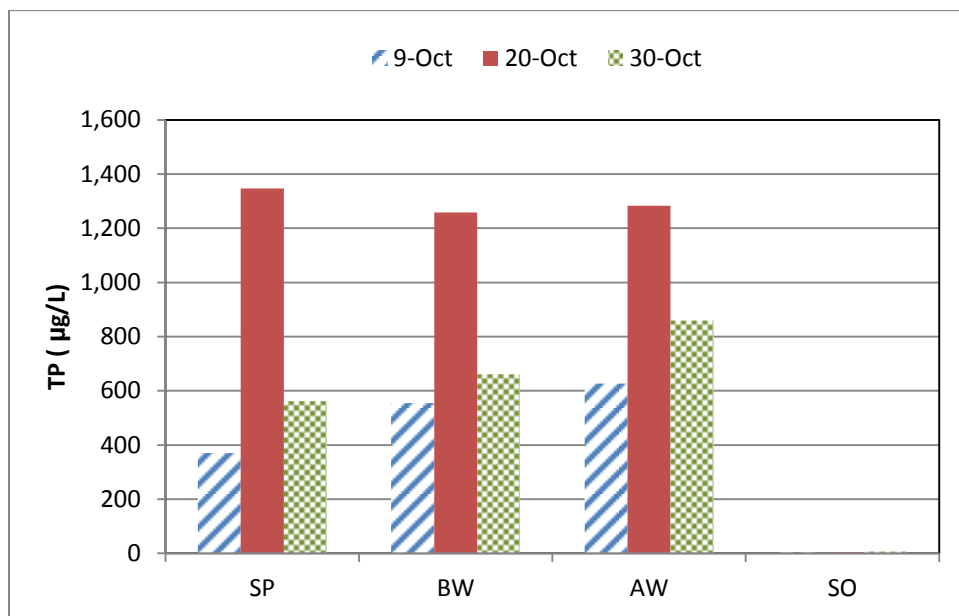
**Figure 7. Mean total phosphorus (TP) concentrations (µg/L) for three samples collected Oct. 9, 20, and 30, 2014 from spillway runoff (SP), before proposed wall location (BW), after proposed wall location (AW), and shower water (SO). Samples were collected after a wagon of containers passed under the shower at watering station.**

proposed wall location (AW). Total phosphorus exhibited the same trend on Oct. 9 and 30, but not on Oct. 20. An explanation is not evident for the variation in response between nutrients for the sampling dates; although, it is worth noting that #1 or trade one gallon container plants were passed under shower on Oct. 20 and #3 or trade three gallon plants were passed under shower on other dates.
